**HIGH TEMPERATURE SELF-
LUBRICATING COATINGS
FOR AIR LUBRICATED
FOIL BEARINGS FOR
THE AUTOMOTIVE GAS
TURBINE ENGINE**

Bharat Bhushan
Mechanical Technology Incorporated

April 1980

Prepared for
NATIONAL AERONAUTICS AND SPACE ADMINISTRATION
Lewis Research Center
Under Contract DEN 3-43

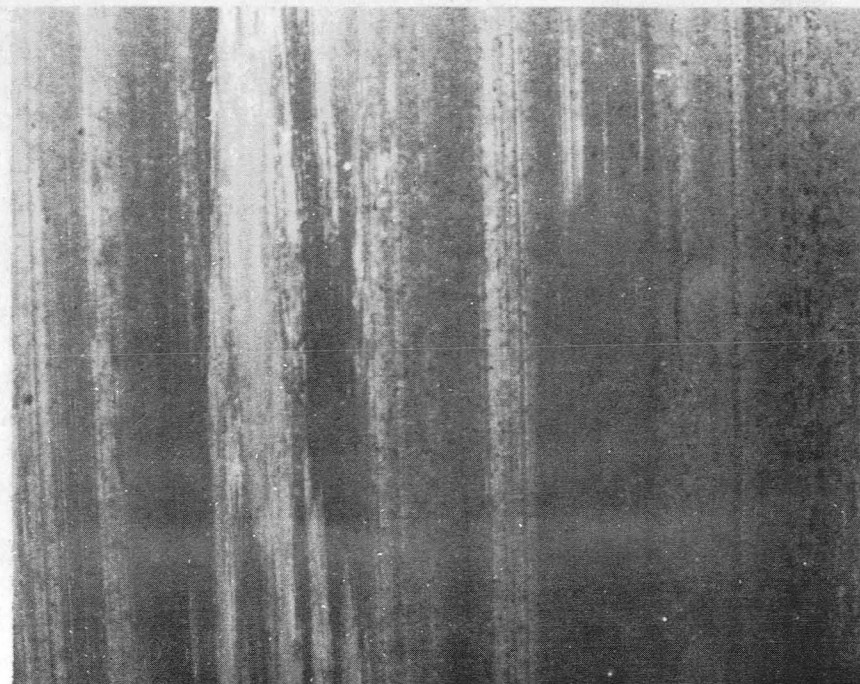
Cr_2O_3 ON FOIL

Fig. IV.19 Photographs of Surfaces After Test
for 3000 Cycles Each at 650°C, IT
and RT
(Test 6)

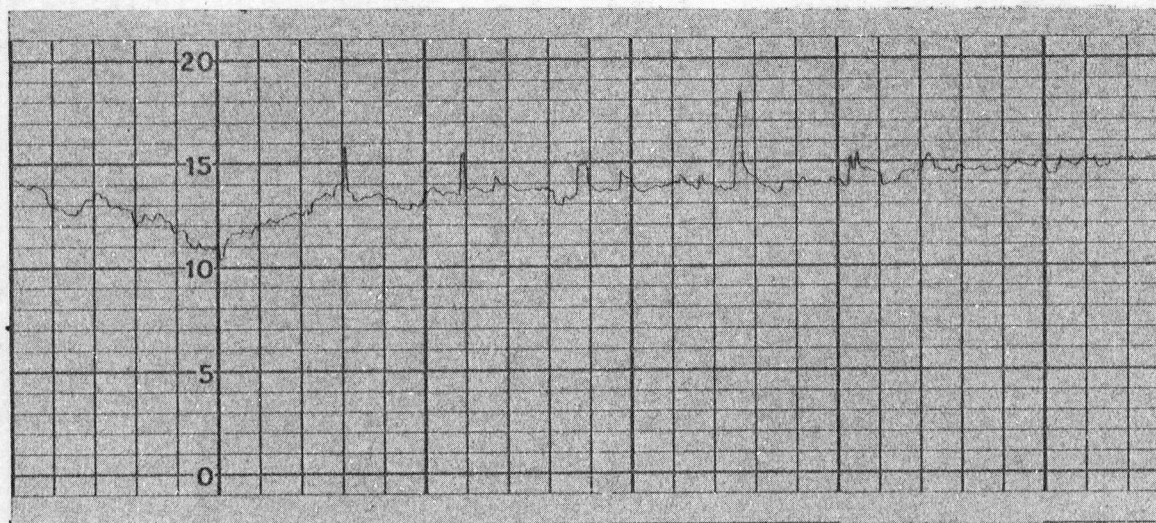
VERTICAL MAG.: EACH SMALL DIV. = $0.05\text{ }\mu\text{m}$

Fig. IV.20 Talysurf Traces of Det. Gun Cr_3C_2
Coated Journal Tested Against
Sputtered Cr_2O_3 Foil for 3000 Cycles
Each at 650°C , IT and RT
(Test No. 6)
